NRCS Actions: NRCS staff have been in the field since Sunday morning, evaluating damage across the entire area affected by the June 7 - 8 storms. We're working closely with local partners, County staff, and the State Dam Safety Engineers, and taking precautions to ensure inspections are completed safely.

High Risk Structures: The Wisconsin State Conservationist has received approval for EWP funds to provide emergency repairs for the following three dams in Vernon County, to prevent further damage or failure -

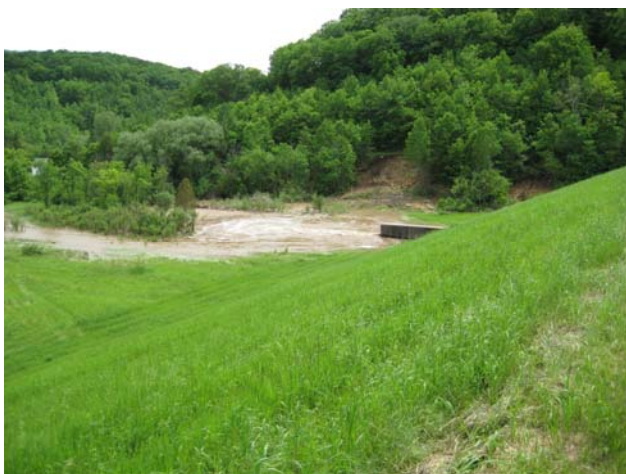
West Fork 17 (Primmer) is in danger of failing. The water level on June 9 was 2 feet over the top riser. Seepage and slumping from the right abutment has moved upstream to the base of the dam. A state highway, 2 homes, and a bridge are at risk downstream from the dam. An emergency controlled partial breach of the dam will begin today (6-11-08).

Primmer – slumping from the abutment

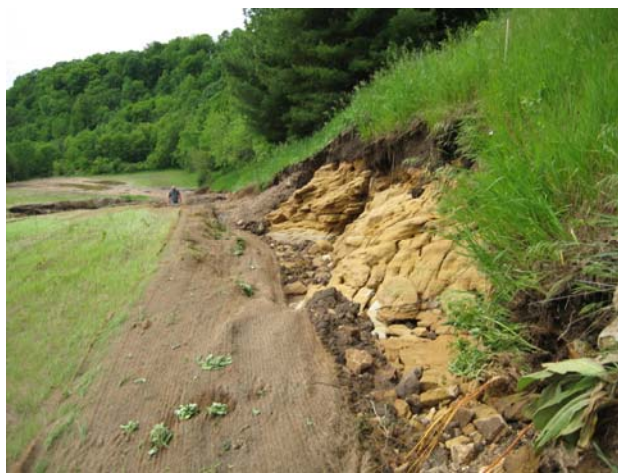
West Fork Kickapoo 4 (Hidden Valley) is in danger of further significant damage with a future rain event. The auxiliary spillway sustained significant erosion.

West Fork 4 – damage to the spillway and abutment
